© JENCOM 2007  
Rivet Clinch Verification

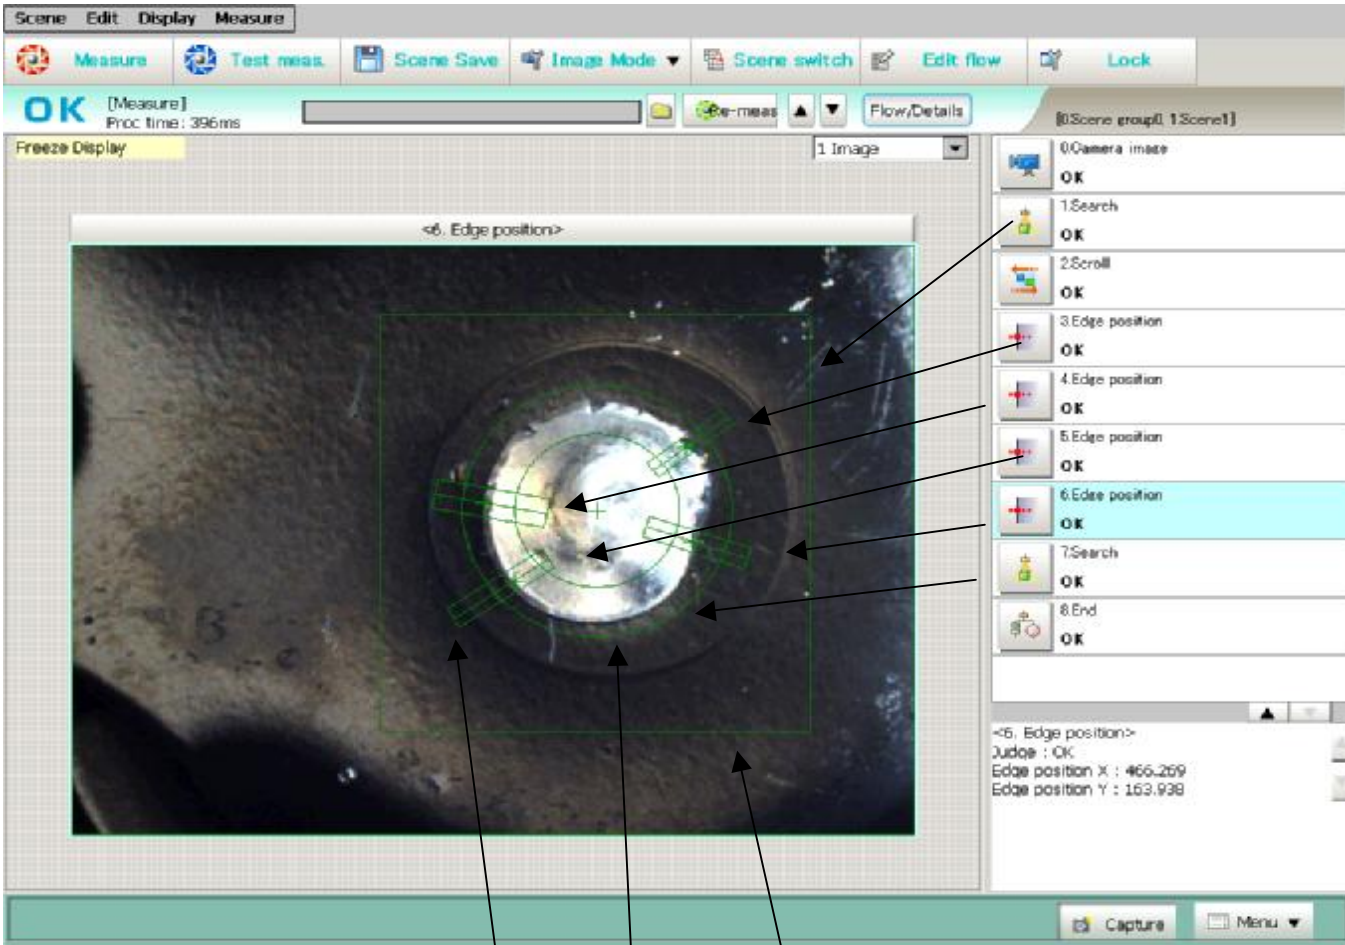
FIG #1 - GOOD PART

Tracking Window

Pattern Inspection Window

Edge Measurement Windows (4) in total for demo.

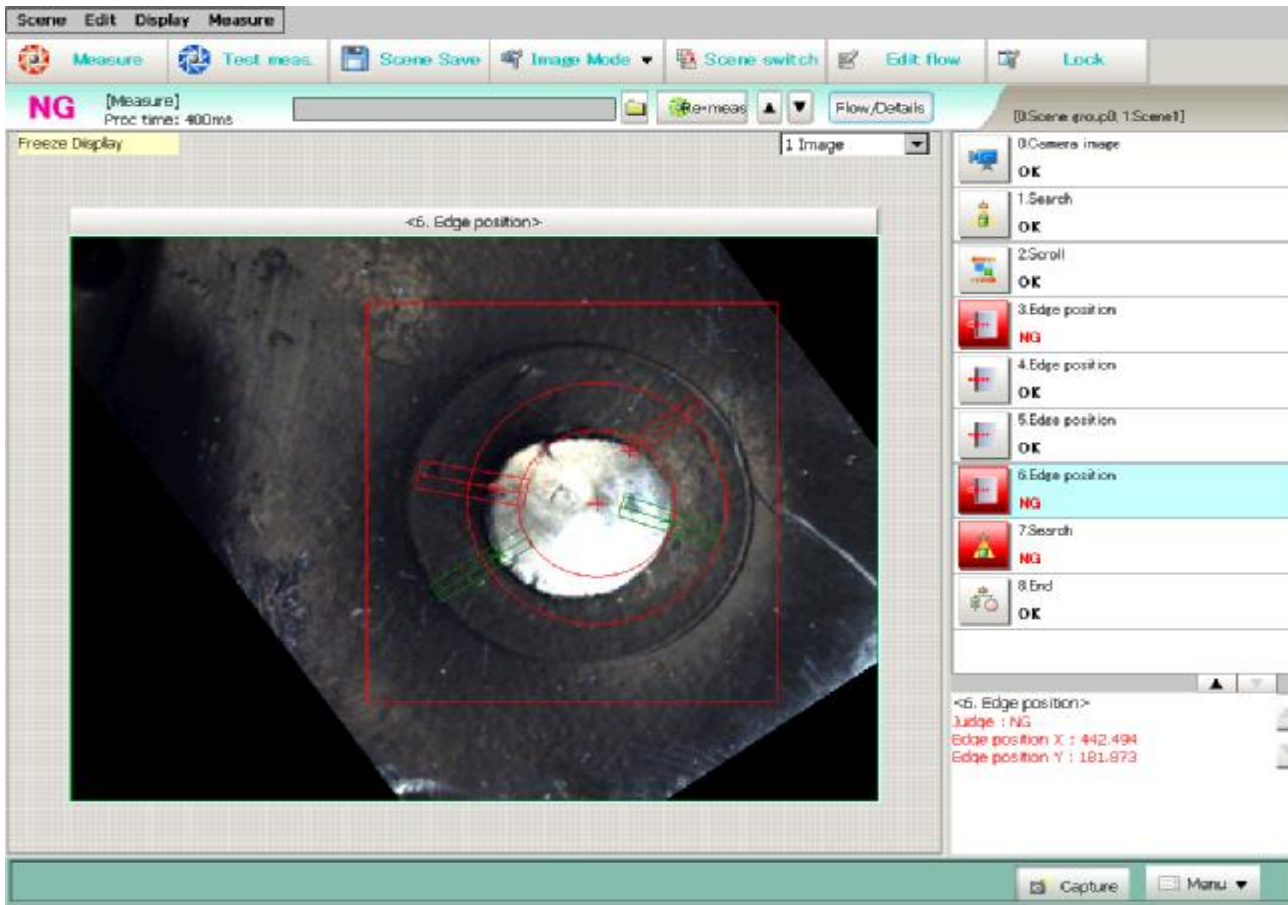
FIG #1 - DEFECTIVE PART
